Steinanes, Arnarlax ehf. B-bottom survey, October 2021 (maximum biomass survey)

Akvaplan-niva AS: APN 63543.B01

Information client						
Titel	Steinanes, Arnarlax ehf.	B-bottom survey, Octobe	er 2021			
Report number	APN-63543.B01					
Site name	Steinanes	Coordinates site	65°40.388 N 023°28.231 V			
County		Municipality	Vesturbyggð			
MTB-or estimated max biomass	7.409 ton	Site manager/contact	Silja Baldvinsdóttir			
Client name	Arnarlax ehf.

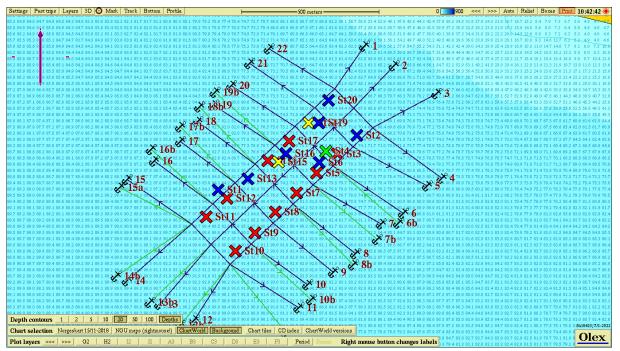
Figure 2. Chart showing depths at the site Steinanes. Sampling stations st. 1-20 are marked with color codes that describe the condition according to NS 9410:2016, chapter 7.11. Color codes: Blue =very good condition, green = good condition, yellow = bad condition, red = very bad condition.

Results for the different parameters are given in Table 5. The overall site condition was 3 «bad» and is the result of the weighted average for all sampling stations. The results were however a little bit mixed with 10 stations having condition bad and 7 stations having condition very good. Overall, the condition for group II parameters (pH/Eh) was 4 «very bad», the condition for group III parameters (sensory) was 2 «good» and condition for combined group II + III parameters was 3 «bad». A complete filled sampling sheet with calculations for each parameter is attached.

For the group II parameters (pH/redox), four out of twenty stations had conditions 1 «very good», one station had conditions 2 «good», two stations had conditions 3 «bad» and ten stations had condition 4 «very bad». For sensory parameters (group III) six out of twenty stations had condition 1 «very good», six stations had condition 2 «good», six stations had condition 3 «bad» and two stations had condition 4 «very bad». For combined parameters II and III (pH/redox and sensory) seven out of twenty stations had condition 1 «very good», one station had conditions 2 «good», two stations had conditions 3 « bad» and ten stations had conditions 4 «very bad». For combined parameters II and III (pH/redox and sensory) seven out of twenty stations had condition 1 «very good», one station had conditions 2 «good», two stations had conditions 3 « bad» and ten stations had conditions 4 «very bad». Animals where present in all soft bottom samples mainly in the form of polychaetes. Gas bubbles were detected in five grab samples (stations 5, 7, 9, 10 and 17) mainly in the eastern part of the local impact zone.

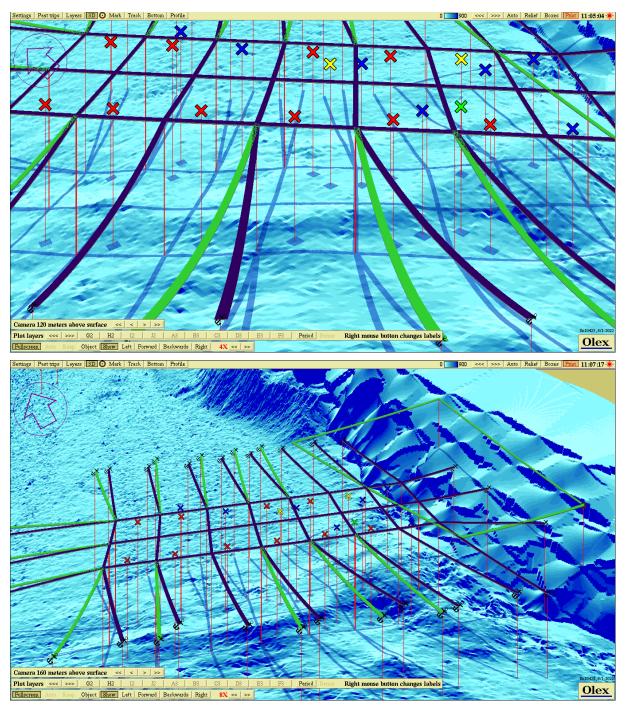
Figure 3. Showing bottom topography 3D at Steinanes with each sampling station according to info in figure 2 and Table 3.

This survey in the local impact zone at max biomass indicates some substantial organic load in the fish farming area mainly in the deeper areas of the local impact zone. The local impact zone is sloping from north to south and from west to east (see Figure 3 in Appendix). The four out of five stations where gas was detected in samples were located in the deeper area (east and south), indicating highest organic load in this part of the local impact zone but to a lesser degree in the shallower areas to west and north at the site. The previous B-survey during fallow period resulted in overall condition 1 «very good» (Gunnarsson 2020b) and the previous B-survey at max biomass in 2018 resulted in overall condition 2 «good». The conditions seem therefore to have deteriorated at the Steinanes site during the farming of present generation and some form of counteractive measures are recommendable.
