# Survey B methodology in effluent area, Gileyri land-based nursery and smolt station Arnarlax, May 2025

**Akvaplan-niva AS Report:**  
**APN 2025 66700.B01**

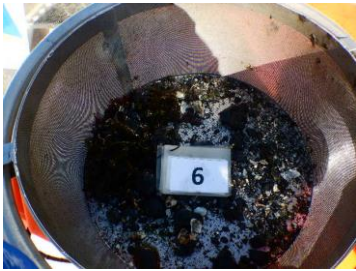
| <b>St 6</b> | A photograph of a dark, irregularly shaped sediment sample placed in a yellow plastic container. A small white label with the number '6' is positioned next to the sample. | A photograph of the same sediment sample from St 6, now placed inside a metal sieve. A small white label with the number '6' is positioned next to the sample. |

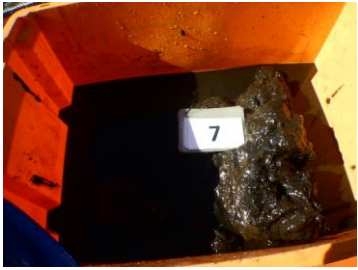
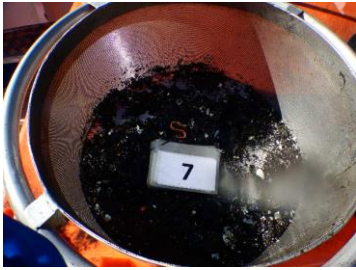
| <b>St 7</b> | A photograph of a dark, irregularly shaped sediment sample placed in a yellow plastic container. A small white label with the number '7' is positioned next to the sample. | A photograph of the same sediment sample from St 7, now placed inside a metal sieve. A small white label with the number '7' is positioned next to the sample. |

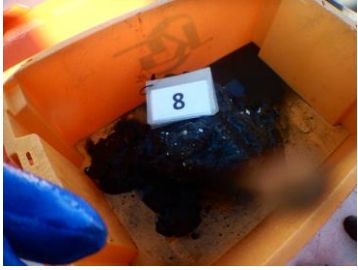
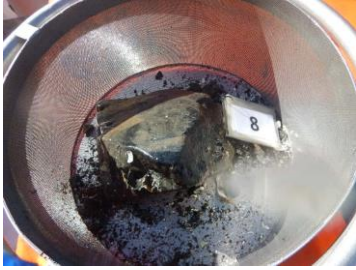
| <b>St 8</b> | A photograph of a dark, irregularly shaped sediment sample placed in a yellow plastic container. A small white label with the number '8' is positioned next to the sample. | A photograph of the same sediment sample from St 8, now placed inside a metal sieve. A small white label with the number '8' is positioned next to the sample. |

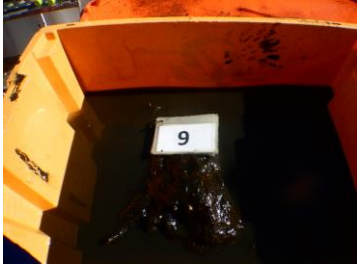
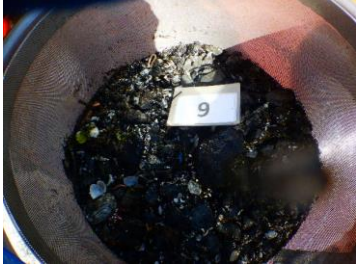
| <b>St 9</b> | A photograph of a dark, irregularly shaped sediment sample placed in a yellow plastic container. A small white label with the number '9' is positioned next to the sample. | A photograph of the same sediment sample from St 9, now placed inside a metal sieve. A small white label with the number '9' is positioned next to the sample. |

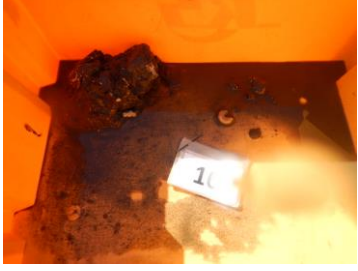
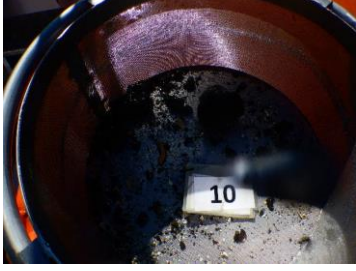
| <b>St 10</b> | A photograph of a dark, irregularly shaped sediment sample placed in a yellow plastic container. A small white label with the number '10' is positioned next to the sample. | A photograph of the same sediment sample from St 10, now placed inside a metal sieve. A small white label with the number '10' is positioned next to the sample. |

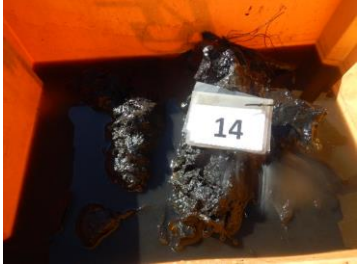
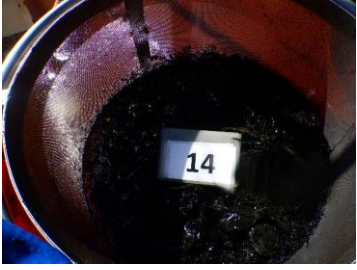
| <b>St 14</b> | | |

| Gr | Parameter | Point | Sample number | | | | | | | | | | Index | |
|---|---|---|---|---|---|---|---|---|---|---|---|---|---|---|
| | Status station | | 1 | 1 | 1 | 3 | 1 | 1 | 1 | 1 | 1 | 1 | | |

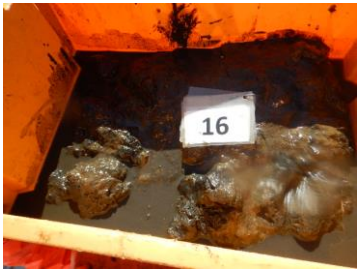
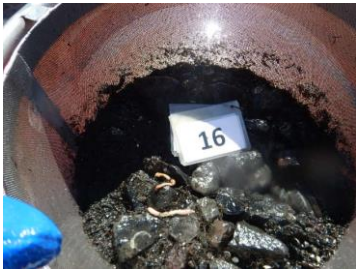
| <b>St 16</b> | A photograph of a sample labeled '16' in a white tag, placed inside a dark, possibly black, container. The sample appears to be a dark, irregular mass, possibly a rock or sediment, resting on a light-colored surface. | A photograph of the same sample labeled '16' in a white tag, now placed inside a red mesh sieve. The sample is surrounded by a dark, granular material, likely sediment or soil. |

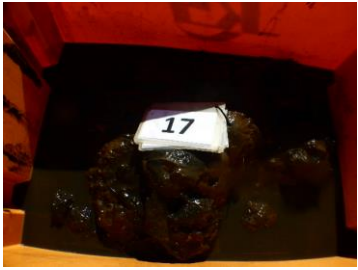
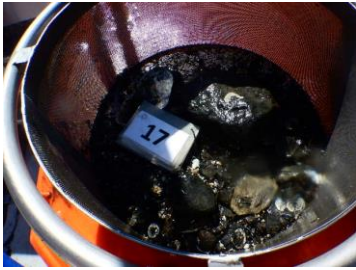
| <b>St 17</b> | A photograph of a sample labeled '17' in a white tag, placed inside a dark container. The sample is a dark, irregular mass, possibly a rock or sediment, resting on a light-colored surface. | A photograph of the same sample labeled '17' in a white tag, now placed inside a red mesh sieve. The sample is surrounded by a dark, granular material, likely sediment or soil. |

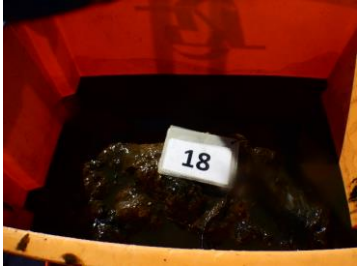
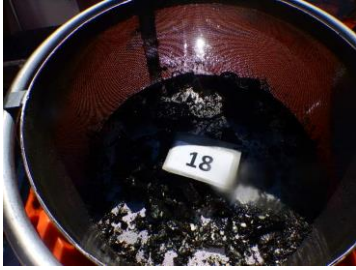
| <b>St 18</b> | A photograph of a sample labeled '18' in a white tag, placed inside a dark container. The sample is a dark, irregular mass, possibly a rock or sediment, resting on a light-colored surface. | A photograph of the same sample labeled '18' in a white tag, now placed inside a red mesh sieve. The sample is surrounded by a dark, granular material, likely sediment or soil. |

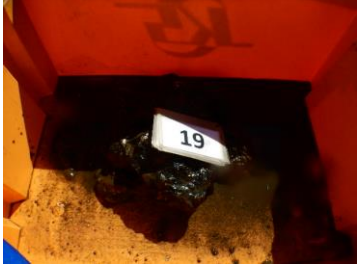
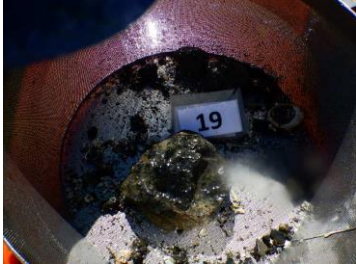
| <b>St 19</b> | A photograph of a sample labeled '19' in a white tag, placed inside a dark container. The sample is a dark, irregular mass, possibly a rock or sediment, resting on a light-colored surface. | A photograph of the same sample labeled '19' in a white tag, now placed inside a red mesh sieve. The sample is surrounded by a dark, granular material, likely sediment or soil. |

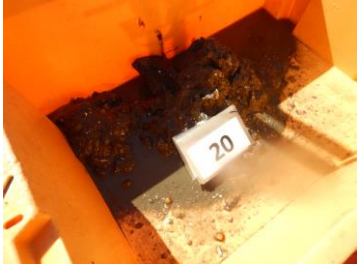
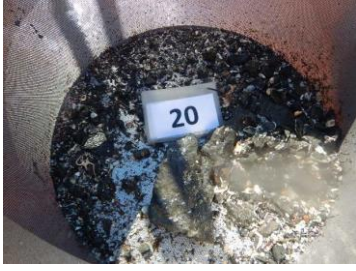
| <b>St 20</b> | A photograph of a sample labeled '20' in a white tag, placed inside a dark container. The sample is a dark, irregular mass, possibly a rock or sediment, resting on a light-colored surface. | A photograph of the same sample labeled '20' in a white tag, now placed inside a red mesh sieve. The sample is surrounded by a dark, granular material, likely sediment or soil. |
